Proper Thermography Inspection of Control Panels to Assure Reliable Operation

Ali M. Eshtaba, Ahmed M. Algadal, Mohamed S. Ahmed, Abdulmunam Alafshouk

Faculty of Engineering Technology, Janzour, Libya

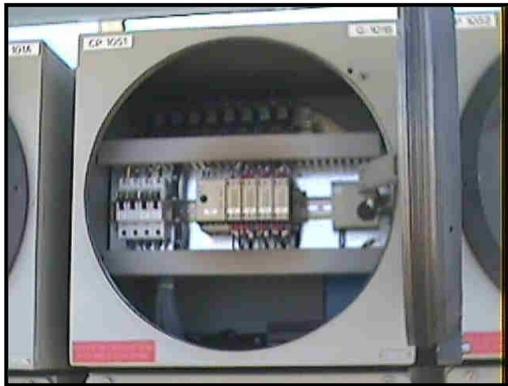
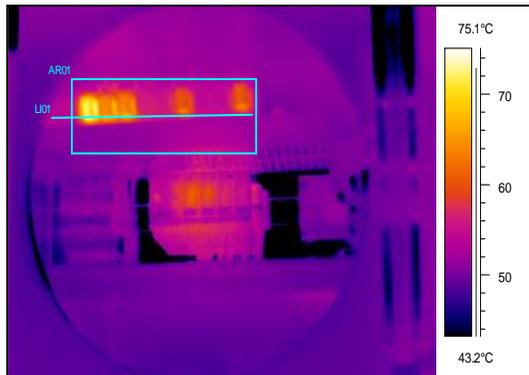
<i>Section</i>	GOSP A
<i>Equipment</i>	Control panel for G-101 B T.pump
<i>Additional information</i>	Connections
<i>Date</i>	
<i>Time</i>

- i. Hot connections on control panel, a hot connections detected on a control panel of Transferring pump as illustrated below. Excessive temperature rise required attention at monthly schedule.

<i>Object parameter</i>	<i>value</i>
<i>Emissivity</i>	0.98
<i>Object distance</i>	2.0 m
<i>Label</i>	<i>value</i>
<i>LI01: max</i>	74.5 °C
<i>AR01: max</i>	74.5 °C
<i>Fault</i>	INTERMEDIATE

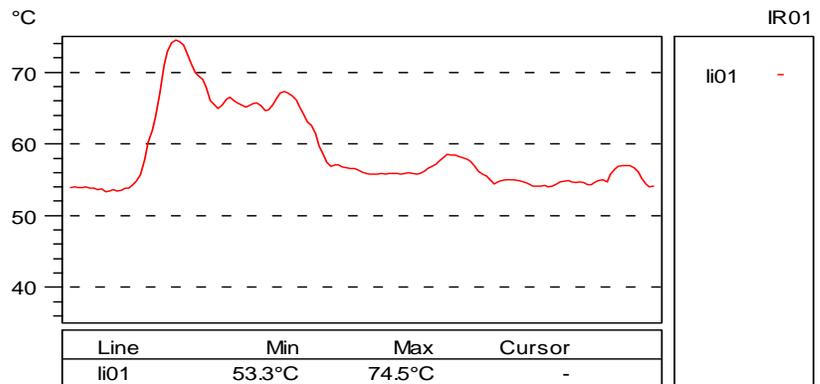
Based on infrared inspection data we have collected on Control panel for G-101B Transfer Pump, we have found

Thermal Profile Shows Intermediate Temperature Rise (74.5C) on Connections

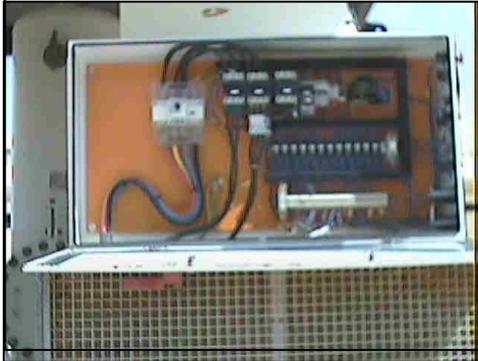
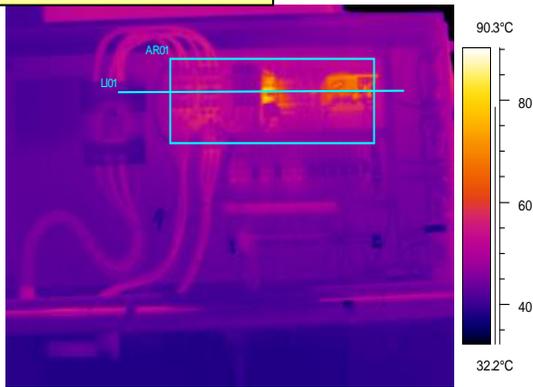
<i>Section</i>	<i>GOSP A</i>
<i>Equipment</i>	<i>Control panel for C-154 N.COMP</i>
<i>Additional information</i>	<i>Protection Relays</i>
<i>Date</i>	
<i>Time</i>

ii. Serious temperature raise at Protection Relays an control panel requires attention as soon as possible.

<i>Object parameter</i>	<i>value</i>
<i>Emissivity</i>	<i>0.98</i>
<i>Object distance</i>	<i>3.0 m</i>
<i>Label</i>	<i>value</i>
<i>L101: max</i>	<i>83.2 °C</i>
<i>AR01: max</i>	<i>83.2 °C</i>
<i>Fault</i>	<i>SERIOUS</i>

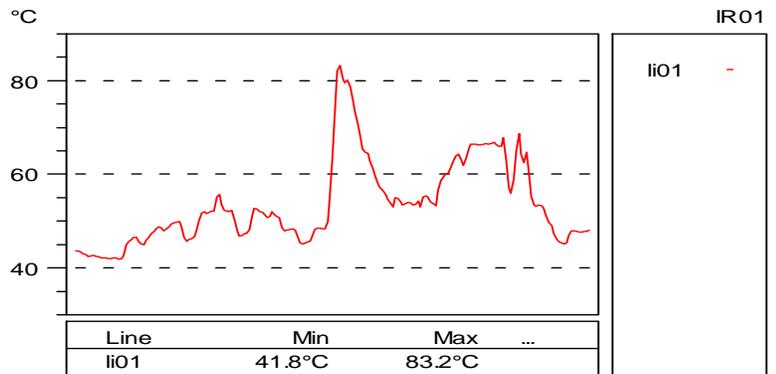
Thermal profile shows a Serious temperature rise(83.2 C) on Protection Relays.

Based on infrared inspection data we have collected on Control Panel for C-154 Nitrogen Compressor, we have found that temperature rise are Excessive and we recommend a proper inspection ASAP to ensure the reliability and safety .
